Clear Path Home Inspections

Home Inspection Report

1842 Cedar Ridge Lane, Greenville, SC

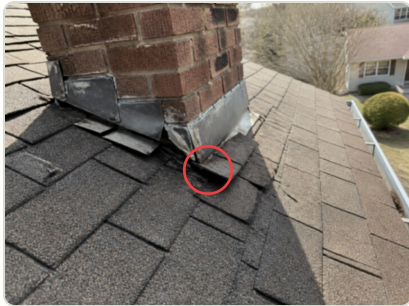
Flashings

Damaged flashing was observed at the chimney. Recommend repair by a qualified roofer.

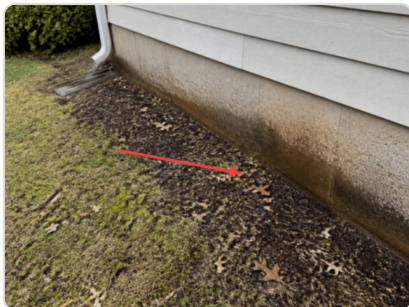
Grading and drainage

Soil slopes toward the foundation and staining was visible. Recommend improving drainage away from the structure.

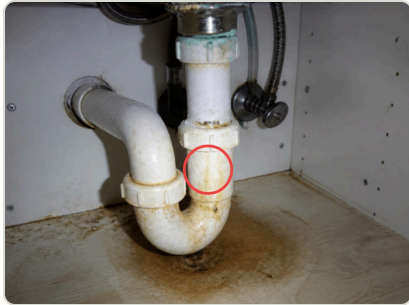
Drain, waste, and vent

Leak staining/corrosion was observed below the sink drain trap. Recommend plumber evaluation and repair.

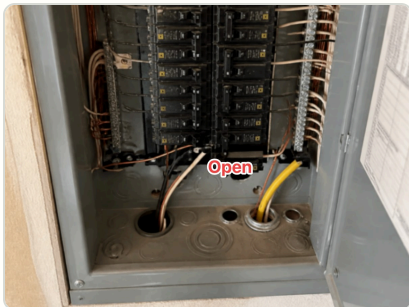
Main panel

Open panel knockouts were observed. Recommend approved filler plates to reduce shock/fire risk.

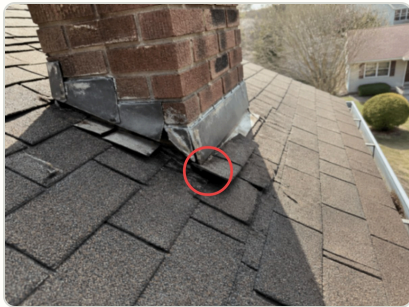
Flashings

Damaged or poorly sealed flashing was observed. Recommend correction by a qualified roofing contractor to reduce the chance of water intrusion.

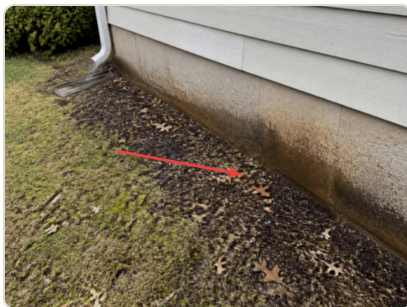
Grading and drainage

Soil appears to slope toward the structure in one or more areas. Recommend improving grading to direct water away from the foundation.

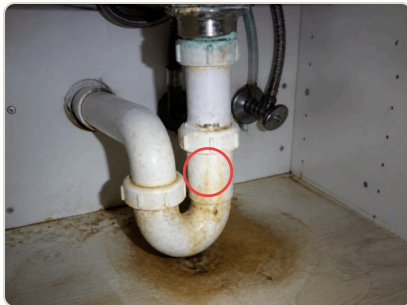
Drain, waste, and vent

Corrosion and staining were observed below the sink drain trap. Recommend repair and further evaluation by a qualified plumber.

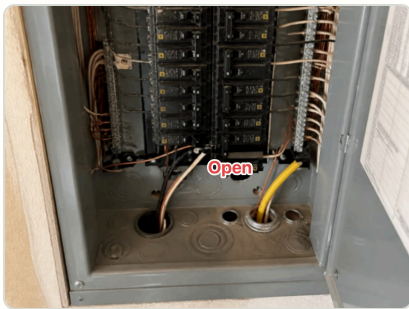
Main panel

Open knockouts were observed at the electrical panel. Recommend installing approved filler plates to reduce shock and fire risk.
